**Flood Control Project Maintenance
Levee Inspections**

Maintenance Issue Types Only, Levee Inspection Report By Mile - Fall 2015

Sacramento Maintenance Yard West Levee Yolo Bypass

Waterway	Bank	Unit Miles	Inspection Start/End	Inspector
Unit No. 01 West Levee	Right	2.73	09/30/2015 09/30/2015	Jai Lor

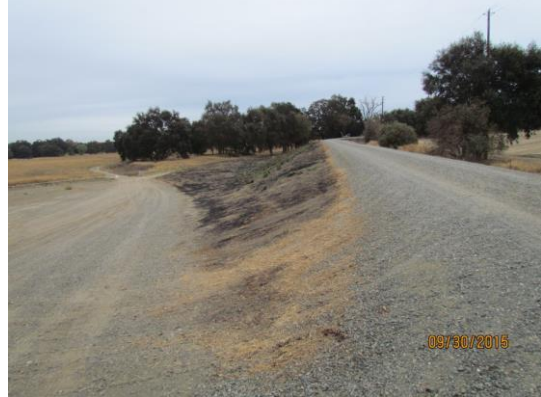
Photo 1 of 1 : FA_2015_ST0011_291_9_20151005_00009.jpg

LM Start	0.00	Rating **	A	Issue No.	9
LM End	2.73	Issue Type +	Ma	Location *	WS
Category	Earthen Levee			GPS Latitude/Longitude	
				Start	End
Item	Vegetation			38.758939 °	38.724262 °
				-121.667569 °	-121.665240 °
DWR ID	DWR_ST0011_01_f_2015_9				
Action/Comments					
Control annual grass and weeds on the levee slopes and easements. Inspector Comments: LMA has burned the slope.

View of the vegetation on the waterward side of the levee looking downstream. Fall 2015.

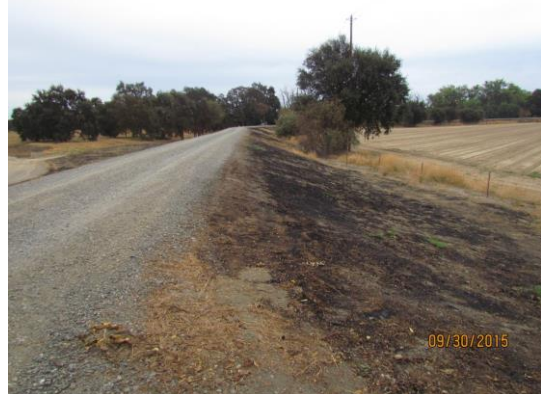
Photo 1 of 1 : FA_2015_ST0011_291_3_20151005_00008.jpg

LM Start	0.00	Rating **	A	Issue No.	3
LM End	2.73	Issue Type +	Ma	Location *	LS
Category	Earthen Levee			GPS Latitude/Longitude	
				Start	End
Item	Vegetation			38.758937 °	38.724262 °
				-121.667567 °	-121.665240 °
DWR ID	DWR_ST0011_01_f_2015_3				
Action/Comments					
Control annual grass and weeds on the levee slopes and easements. Inspector Comments: LMA has burned the slope.

View of the vegetation on the landward side of the levee looking downstream. Fall 2015.

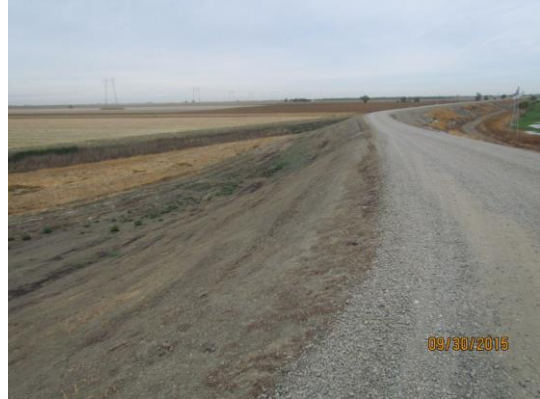
Photo 1 of 1 : FA_2015_ST0011_292_4_20151005_00003.jpg

LM Start	0.00	Rating **	A	Issue No.	4
LM End	1.51	Issue Type +	Ma	Location *	LS
Category	Earthen Levee			GPS Latitude/Longitude	
				Start	End
Item	Vegetation			38.719079 °	38.698710 °
				-121.664135 °	-121.674142 °
DWR ID	DWR_ST0011_02_f_2015_4				
Action/Comments					
Control annual grass and weeds on the levee slopes and easements. Inspector Comments: Slope has been burned and dragged.

View of the vegetation on the landward side of the levee looking upstream. Fall 2015.

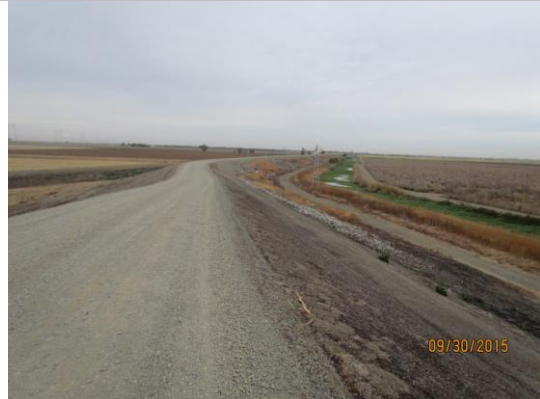
Photo 1 of 1 : FA_2015_ST0011_292_6_20151005_00004.jpg

LM Start	0.00	Rating **	A	Issue No.	6
LM End	1.51	Issue Type +	Ma	Location *	WS
Category	Earthen Levee			GPS Latitude/Longitude	
				Start	End
Item	Vegetation			38.719079 °	38.698710 °
				-121.664135 °	-121.674142 °
DWR ID	DWR_ST0011_02_f_2015_6				
Action/Comments					
Control annual grass and weeds on the levee slopes and easements. Inspector Comments: Slope has been burned and dragged.

View of the vegetation on the waterward side of the levee looking upstream. Fall 2015.

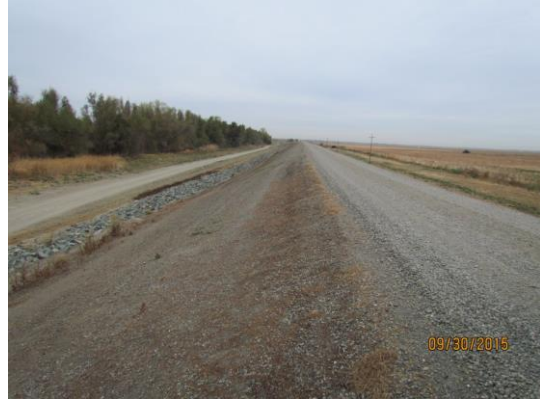
Photo 1 of 1 : FA_2015_ST0011_293_3_20151005_00001.jpg

LM Start	0.00	Rating **	A	Issue No.	3
LM End	1.48	Issue Type +	Ma	Location *	LS
Category	Earthen Levee			GPS Latitude/Longitude	
				Start	End
Item	Vegetation			38.698617 °	38.677234 °
				-121.674141 °	-121.672804 °
DWR ID	DWR_ST0011_03_f_2015_3				
Action/Comments					
Control annual grass and weeds on the levee slopes and easements. Inspector Comments: Slopes have been burned and dragged.

View of the vegetation on the landward side of the levee looking upstream. Fall 2015.

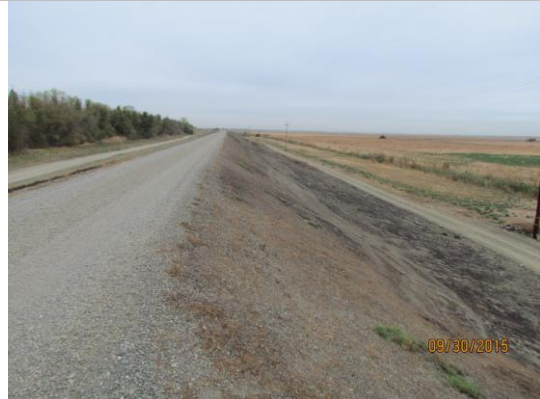
Photo 1 of 1 : FA_2015_ST0011_293_4_20151005_00002.jpg

LM Start	0.00	Rating **	A	Issue No.	4
LM End	1.48	Issue Type +	Ma	Location *	WS
Category	Earthen Levee			GPS Latitude/Longitude	
				Start	End
Item	Vegetation			38.698617 °	38.677234 °
				-121.674141 °	-121.672804 °
DWR ID	DWR_ST0011_03_f_2015_4				
Action/Comments					
Control annual grass and weeds on the levee slopes and easements. Inspector Comments: Slopes have been burned and dragged.

View of the vegetation on the waterward side of the levee looking upstream. Fall 2015.

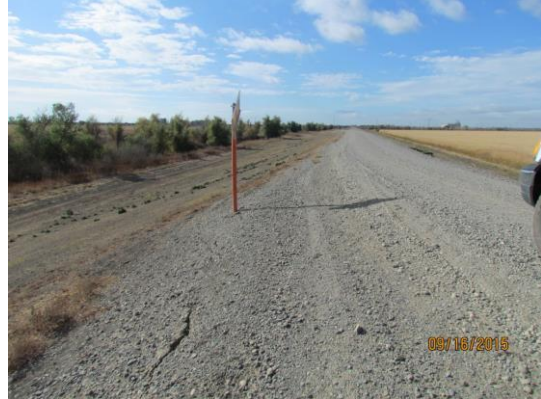
Photo 1 of 1 : FA_2015_ST0011_294_1_20150921_00010.jpg

LM Start	0.00	Rating **	A	Issue No.	1
LM End	3.61	Issue Type +	Ma	Location *	WS
Category	Earthen Levee			GPS Latitude/Longitude	
				Start	End
Item	Vegetation			38.574396 °	38.523647 °
				-121.638741 °	-121.631444 °
DWR ID	DWR_ST0011_04_f_2015_1				
Action/Comments					
Control annual grass and weeds on the levee slopes and easements. Inspector Comments: Vegetation on the waterward side of the levee has been maintained.

View of the vegetation on the waterward side of the levee looking downstream. Fall 2015.

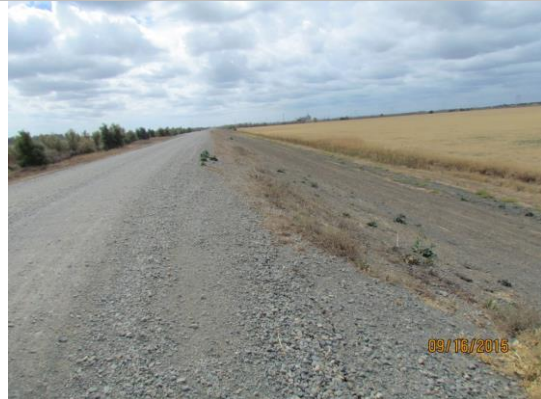
Photo 1 of 1 : FA_2015_ST0011_294_9_20150921_00015.jpg

LM Start	0.00	Rating **	A	Issue No.	9
LM End	3.61	Issue Type +	Ma	Location *	LS
Category	Earthen Levee			GPS Latitude/Longitude	
				Start	End
Item	Vegetation			38.574304 °	38.523647 °
				-121.638753 °	-121.631444 °
DWR ID	DWR_ST0011_04_f_2015_9				
Action/Comments					
Control annual grass and weeds on the levee slopes and easements. Inspector Comments: Vegetation on the landward side of the levee has been maintained.

View of the vegetation on the landward side of the levee looking downstream. Fall 2015.

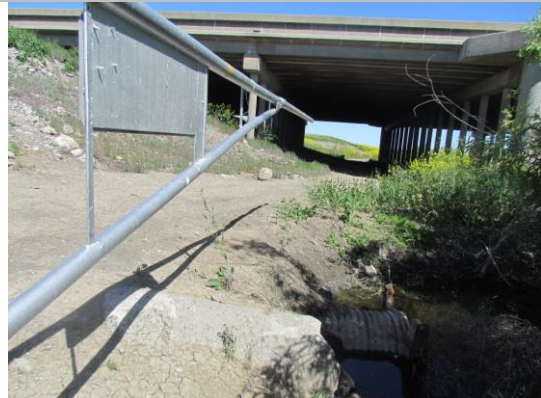
Photo 1 of 2 : FA_2015_ST0011_294_2_20150914_00001.jpg

LM Start	0.78	Rating **	M	Issue No.	2
LM End	0.78	Issue Type +	Ma	Location *	WS
Category	Structures & Concrete Lined Channels			GPS Latitude/Longitude	
				Start	End
Item	Flap Gates			38.563163 °	38.563163 °
				-121.637994 °	-121.637994 °
DWR ID	DWR_ST0011_04_s_2015_2				
Action/Comments					
Inspector Comments: There seems to be obstructions that prevents the gate from fully closing. Remove debris from flap gate.

View of a perspective on the pipe looking upstream. Spring 2015.

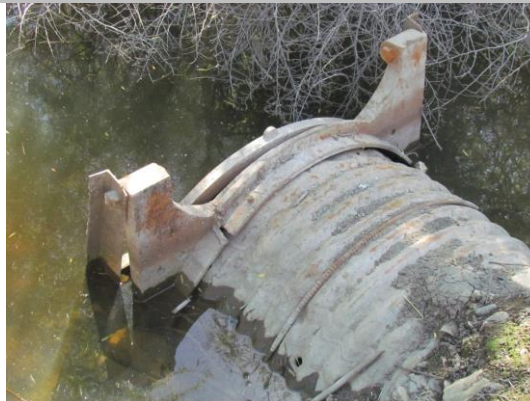
Photo 2 of 2 : FA_2015_ST0011_294_2_20150914_00002.jpg

LM Start	0.78	Rating **	M	Issue No.	2 (cont)
LM End	0.78	Issue Type +	Ma	Location *	WS
Category	Structures & Concrete Lined Channels			GPS Latitude/Longitude	
				Start	End
Item	Flap Gates			38.563163 °	38.563163 °
				-121.637994 °	-121.637994 °
DWR ID	DWR_ST0011_04_s _ 2015_2

Inspector Comments: There seems to be obstructions that prevents the gate from fully closing. Remove debris from flap gate.

View of the flap gate in the ditch on the water side of the levee. There seems to be debris preventing the flap gate from closing. Spring 2015.
